INSPECTION REPORT: KENSINGTON GOLD MINE

Date of Inspection: March 24, 2023
Date of Report: June 21, 2023
USDA Forest Service Inspector: Casey Loofbourrow

Sites visited during the inspection included: Access roads, Comet waste rock storage area, Comet Water Treatment Plant (CWTP), Sherman Creek Outfall 001, Mill Ponds, Pit 4, Fuel Depot, Port Facility, Tailings Treatment Facility (TTF) and access road.

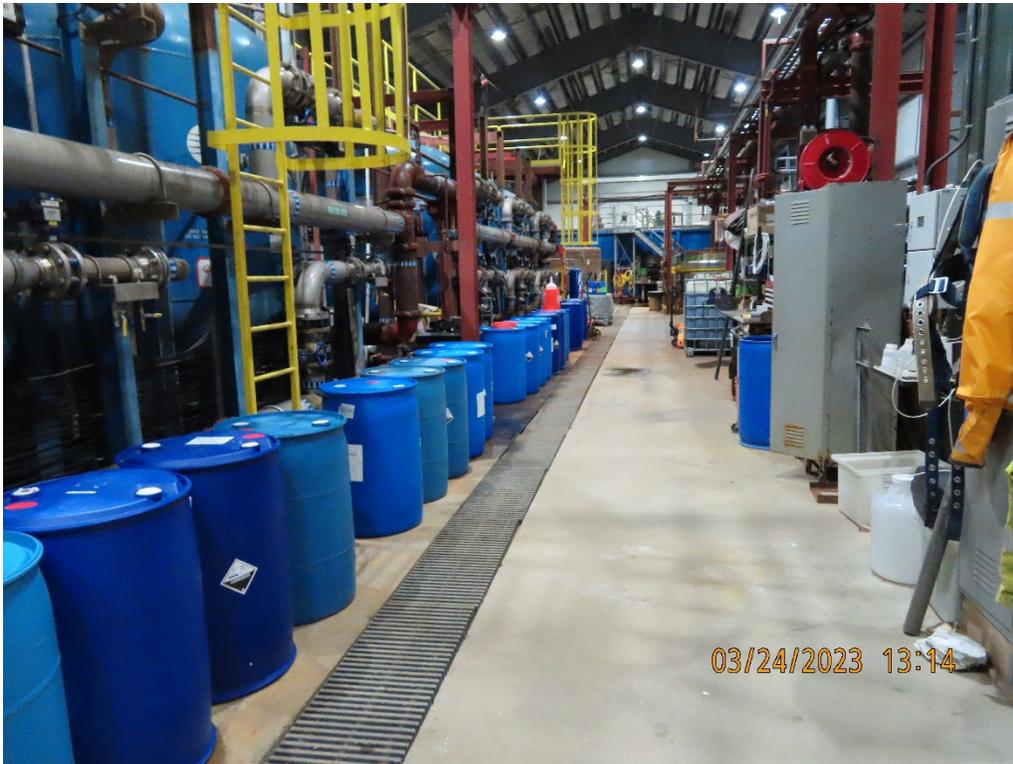
Good housekeeping (Appendix 4g BMP plan; Table 4-1) practices were observed inside the TTF water treatment plant (Photo 29).

Photo 29. TTF WTP interior.

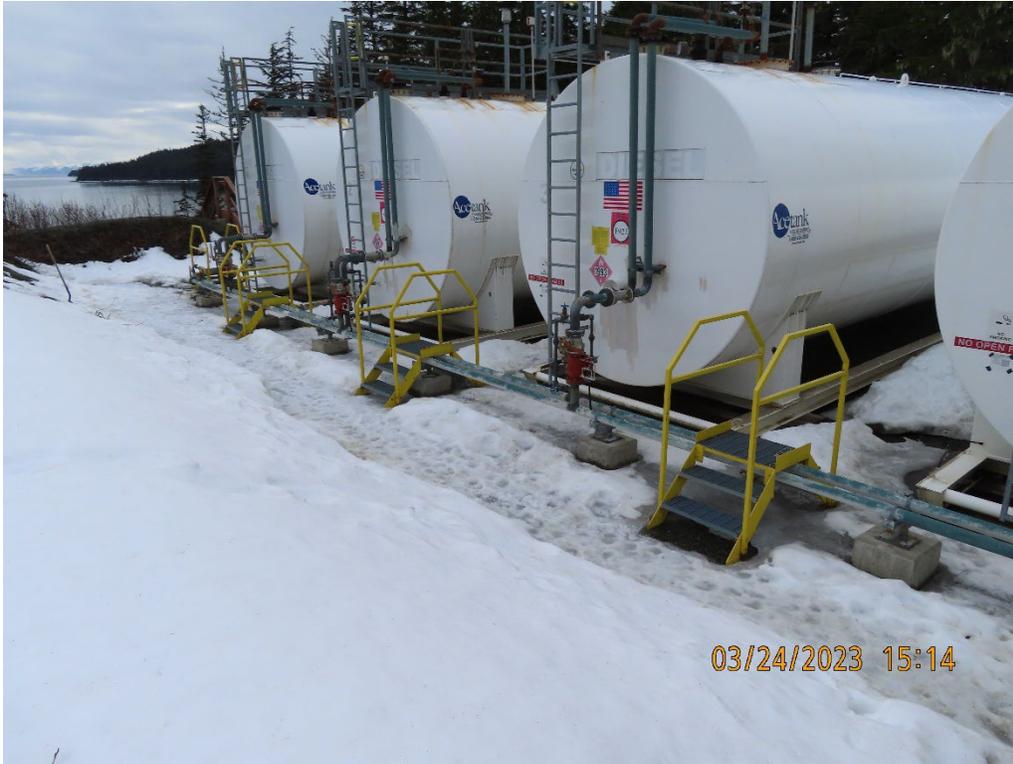
The fuel depot was in good condition with the BMPs functioning as intended. No fuel sheening was observed around the fuel containment area (Photo 30).

Photo 30. Fuel depot near Slave Cove.

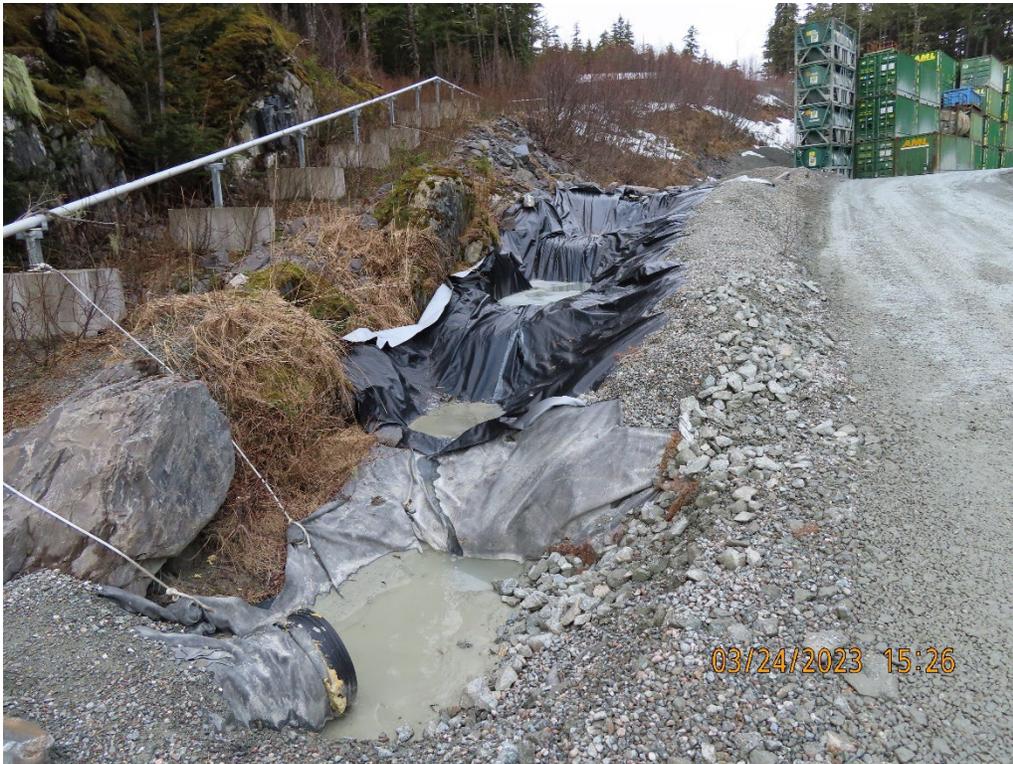
The port facility appeared in good condition. Stormwater BMPs were functioning well (Photo 31).

Photo 31. Stormwater BMP's near port facility.

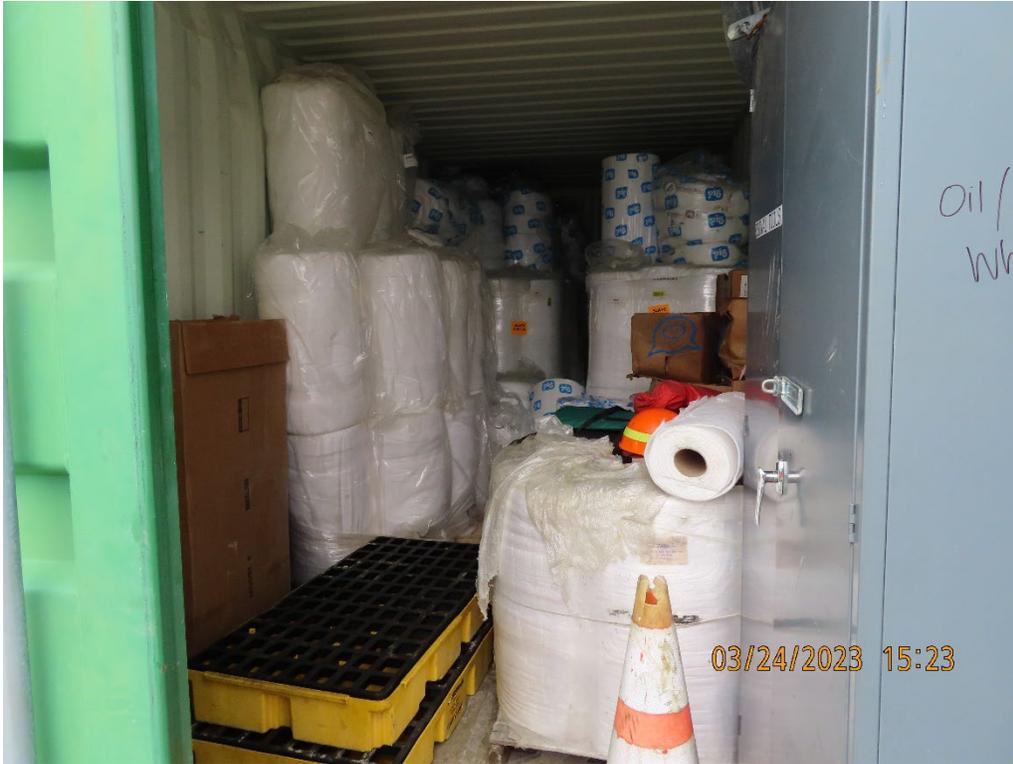
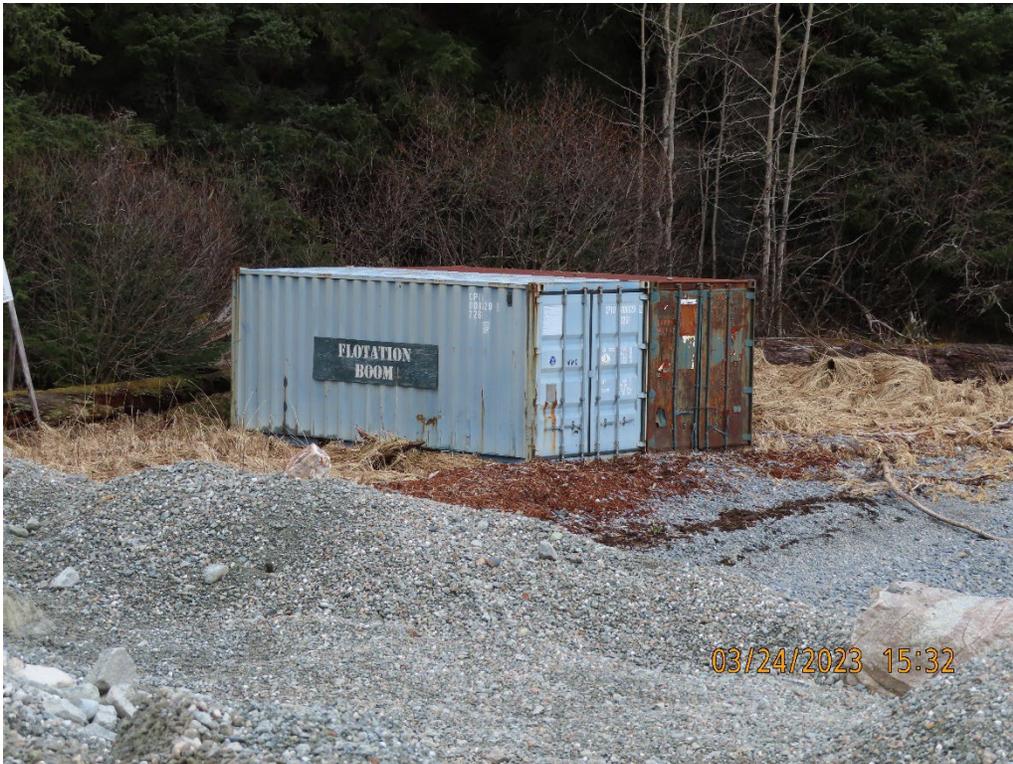
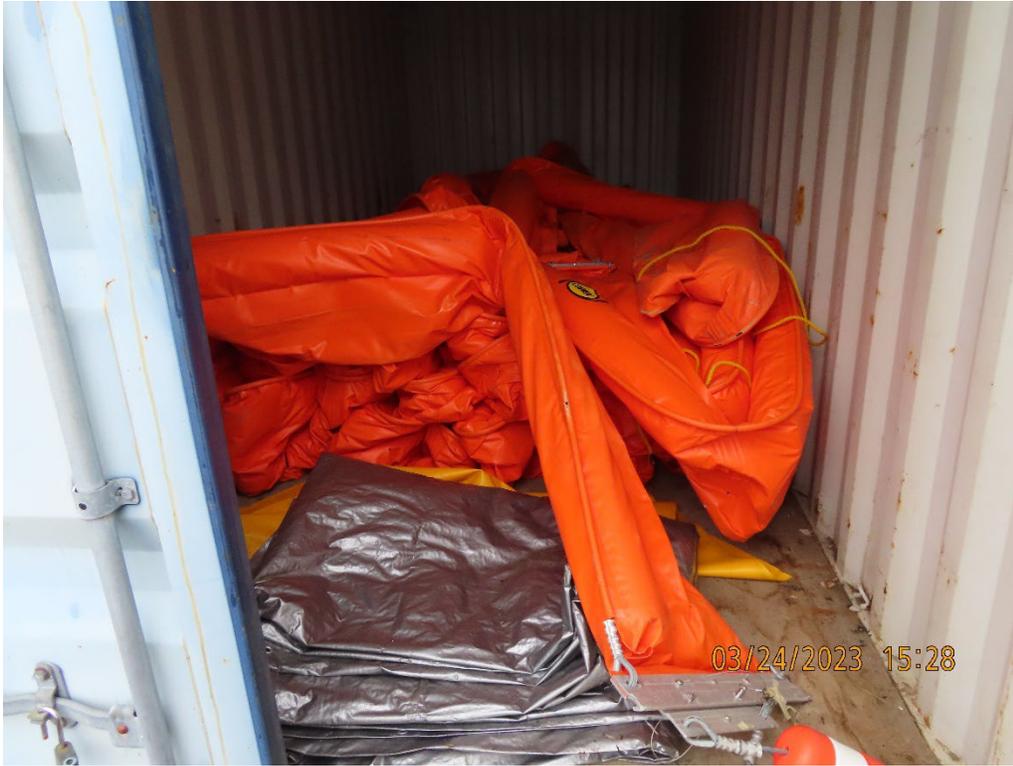
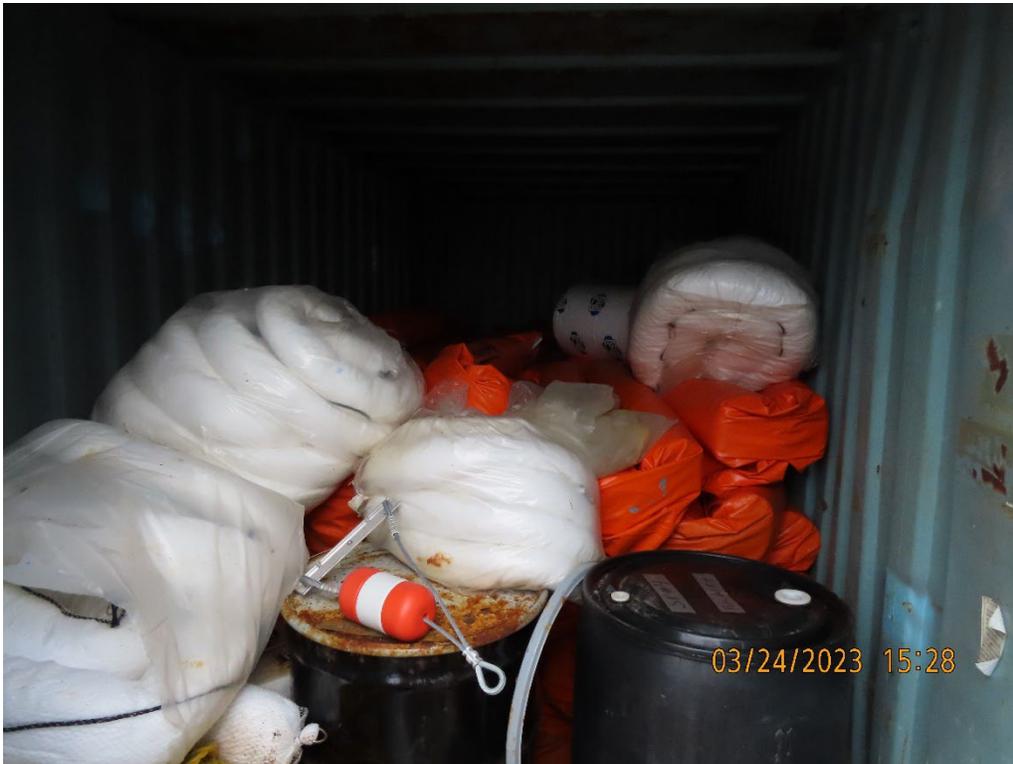
Spill response trailers are present on the bench adjoining the port facilities (Photo 32) and on the beach for marine fuel spill response (Photos 33-35)

Photo 32. Spill response trailer near port facility generator.

Photo 33. Marine fuel spill response trailers.

Photo 34. Marine fuel spill response trailer interior.

Photo 35. Marine fuel spill response trailer interior.
